National Dam Inspection Program.
CADJAW DAM,
WAYNE COUNTY, PENNSYLVANIA

NDS I.D. NO. PA 00168
DER I.D. NO. 64-10

6 PHASE I INSPECTION REPORT.
NATIONAL DAM INSPECTION PROGRAM.

WOODWARD-CLYDE CONSULTANTS
5120 Butler Pike
Plymouth Meeting, Pennsylvania 19462

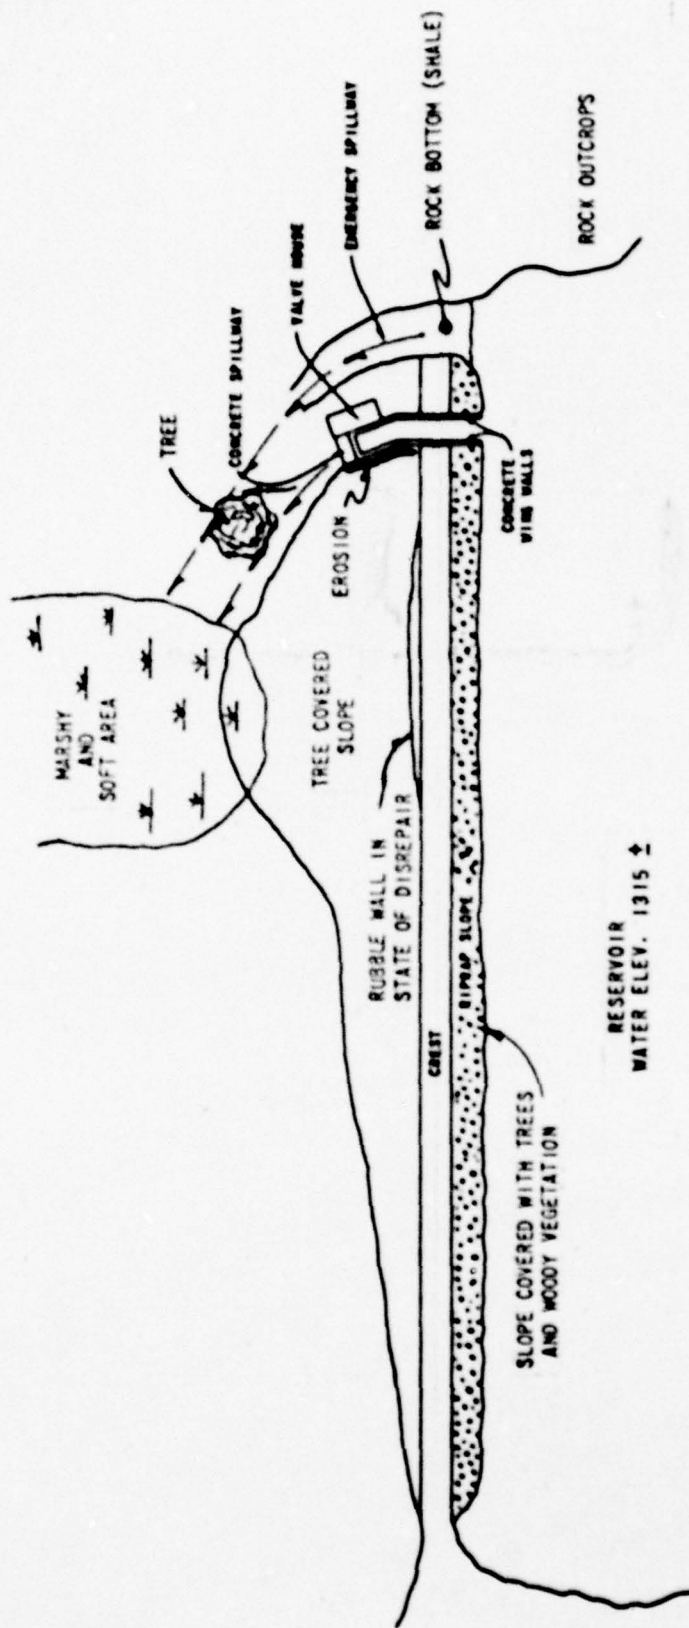
SHEET 5a OF 11

Yes. See Sheet 5a for details. The entire downstream area from just above the dam toe to 50 or more feet downstream is wet and muddy. It appears to be seeping through or under the dam. This condition should be checked and the area stabilized.

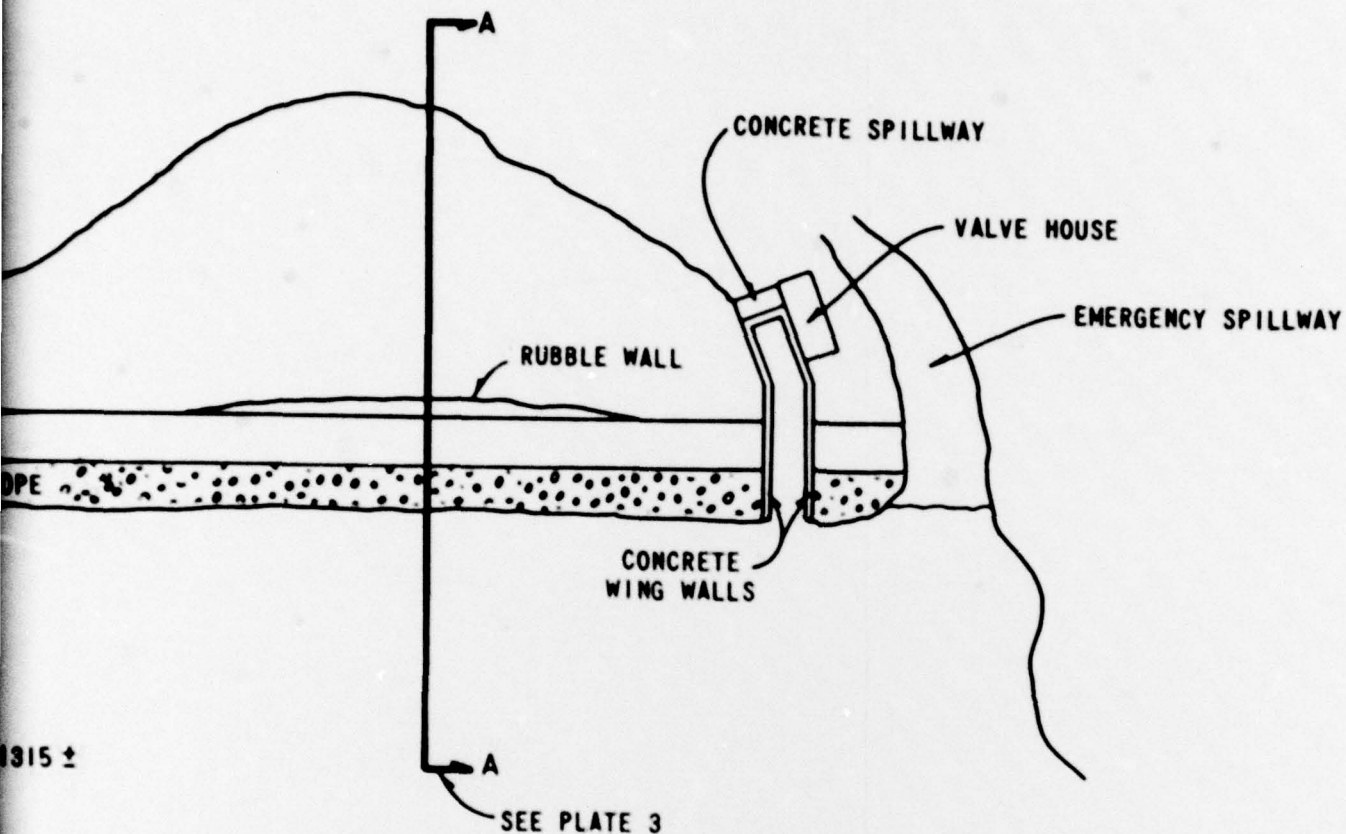
PLATE 2

c. Visual Observations. This inspection disclosed that the emergency spillway control section is smaller than as originally constructed, with a bottom width of about 11 feet. See Plate 2. The height of the spillway wall above the weir is 20 inches at the weir, while at the centerline of the dam, the wall is about 33 inches above the weir. As the spillway channel is 7 feet wide and is not straight, see Plate 4, it is possible that debris would lodge in the spillway during large flows, reducing the discharge. Other observations regarding the condition of the downstream channel, spillway and reservoir are located in Appendix B.
